Photographic Documentation

Name of Facility: US Ecology Site-B

Inspection Date: Monday, November 26, 2018

Purpose of Inspection: November 17 Incident

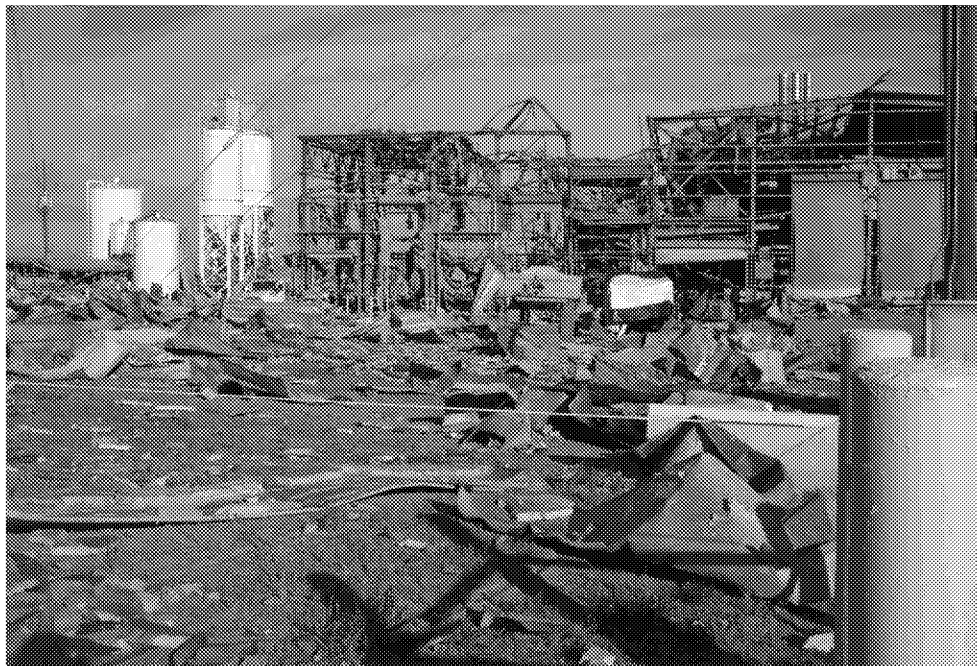
Photograph DCP-7663: Containment building, looking North.

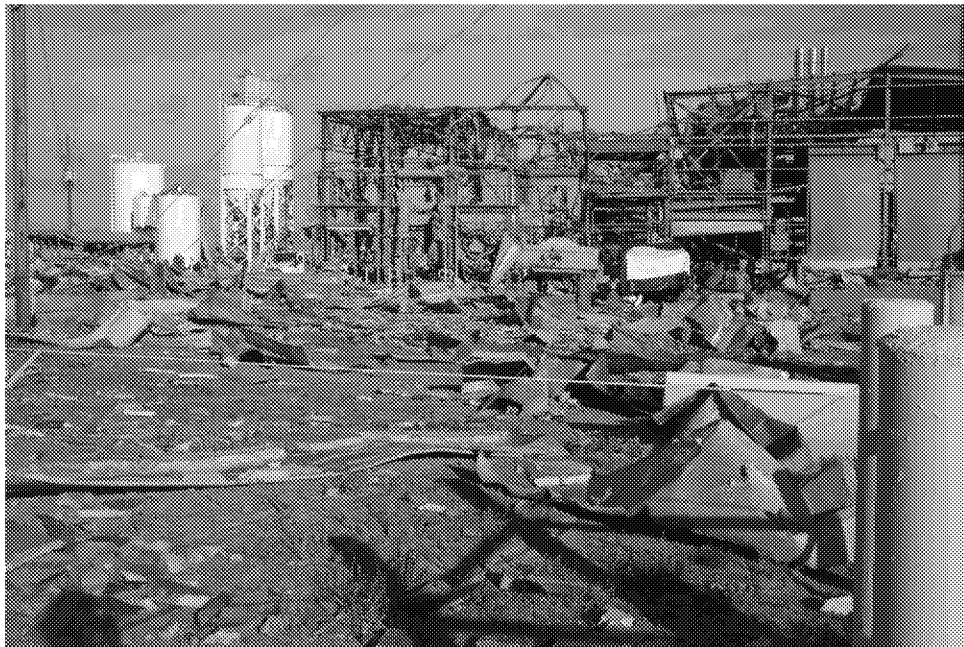
Photograph DCP-7664: Containment building, looking North.

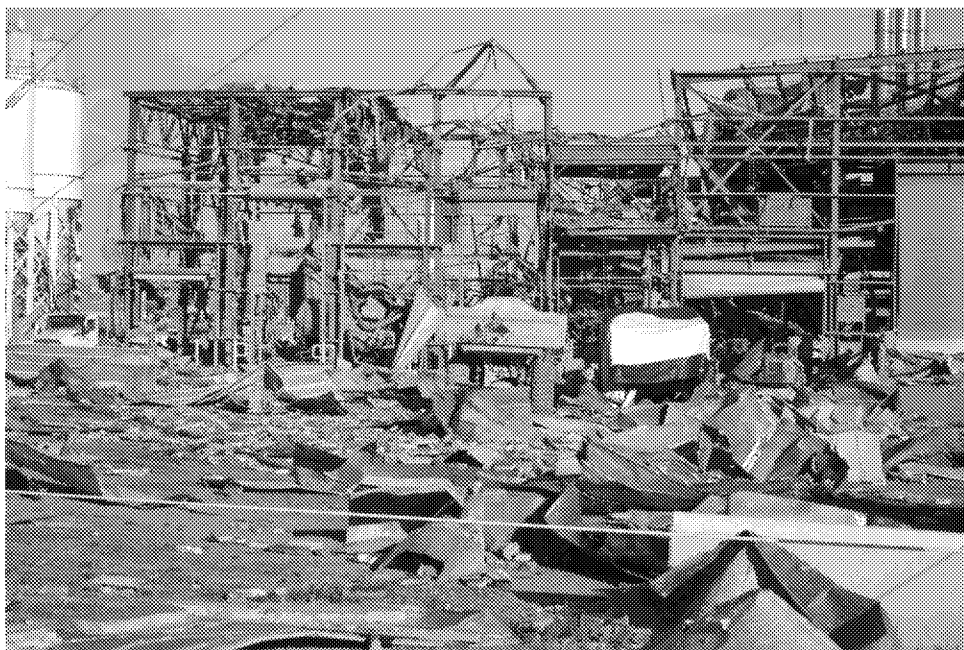
Photograph DCP-7665: Containment building, looking North.

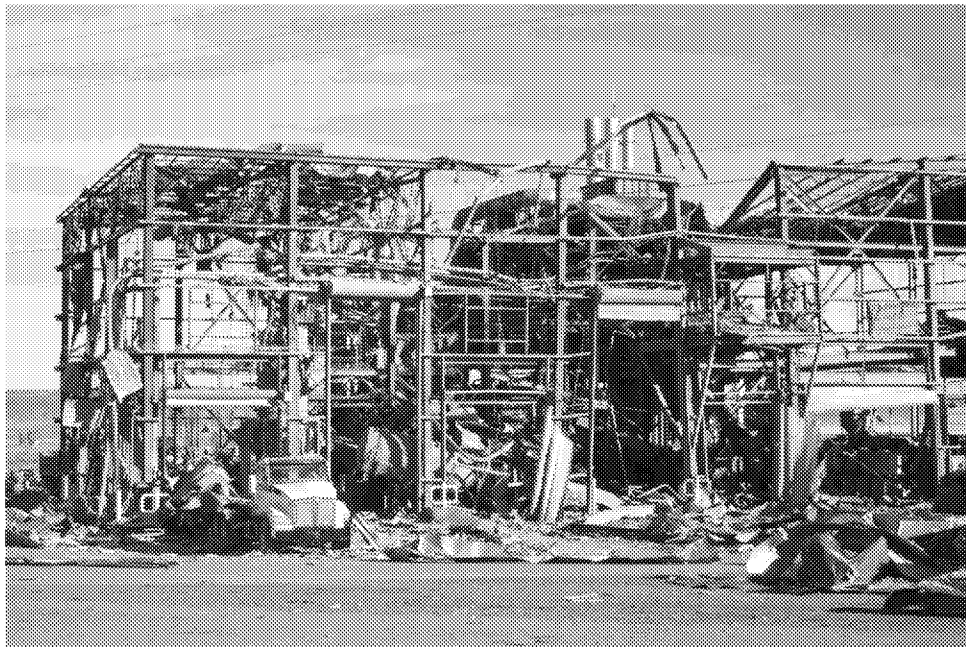
Photograph DCP-7666: Containment building, mixing bin/stabilization area on left half of building, looking Northeast.

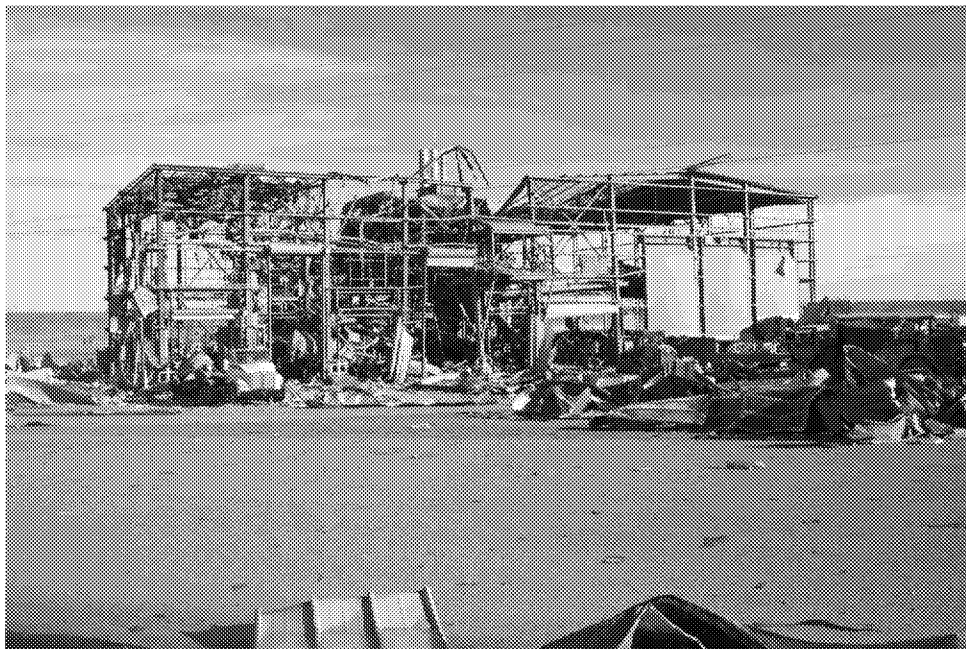
Photograph DCP-7667: Containment building, looking Northeast.

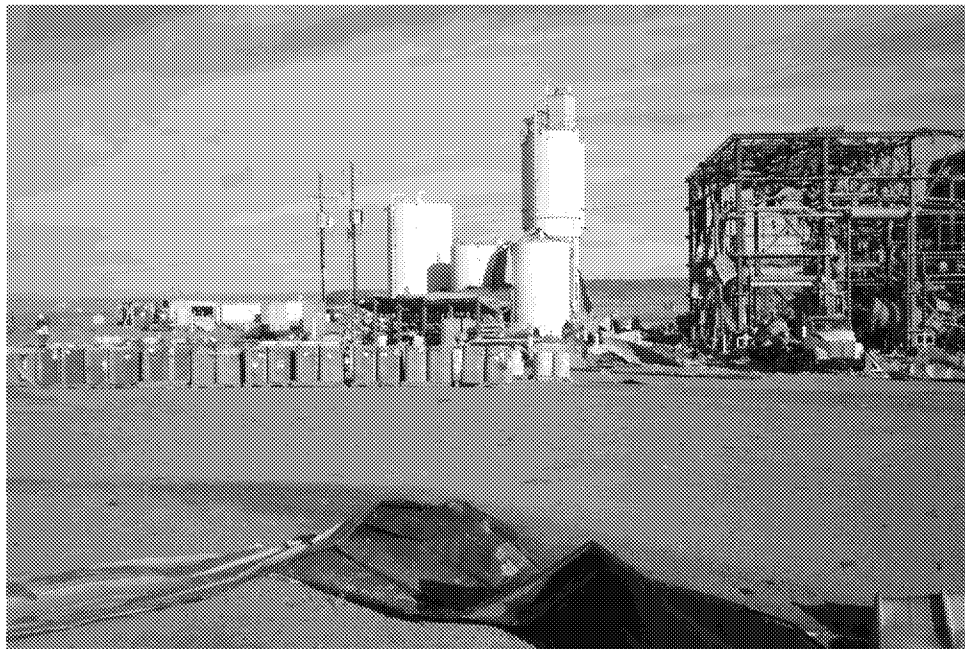
Photograph DCP-7668: Drums staged prior to incident for processing. White water and reagent tanks in background. Sheet metal siding draped over tanks, looking North.

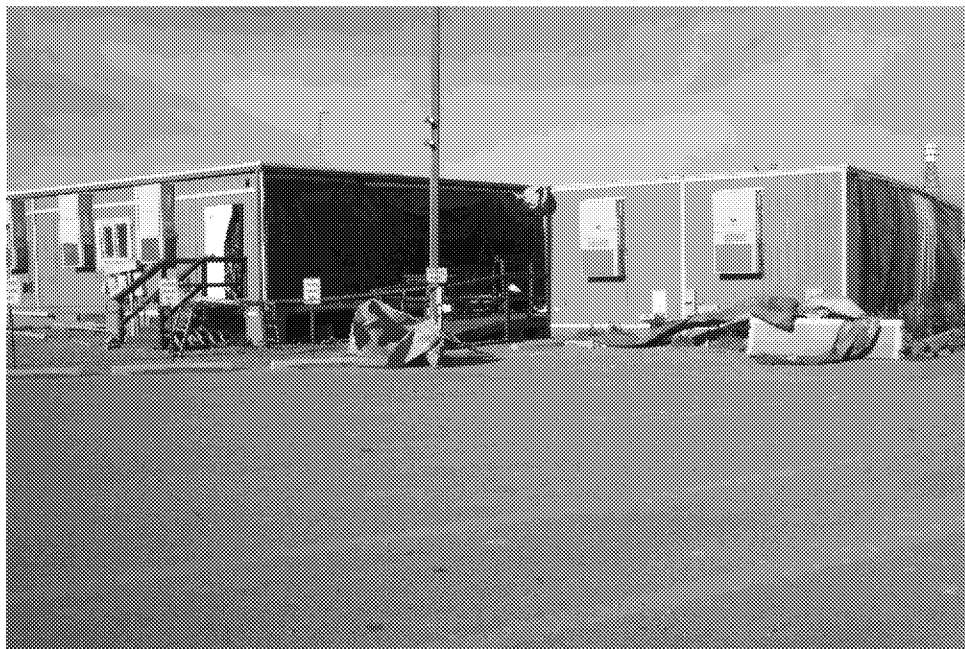
Photograph DCP-7669: Administrative buildings, Plastic covering east walls destroyed in the incident. Window and door distorted on South side of building. Metal siding remains where it landed, looking Northwest.

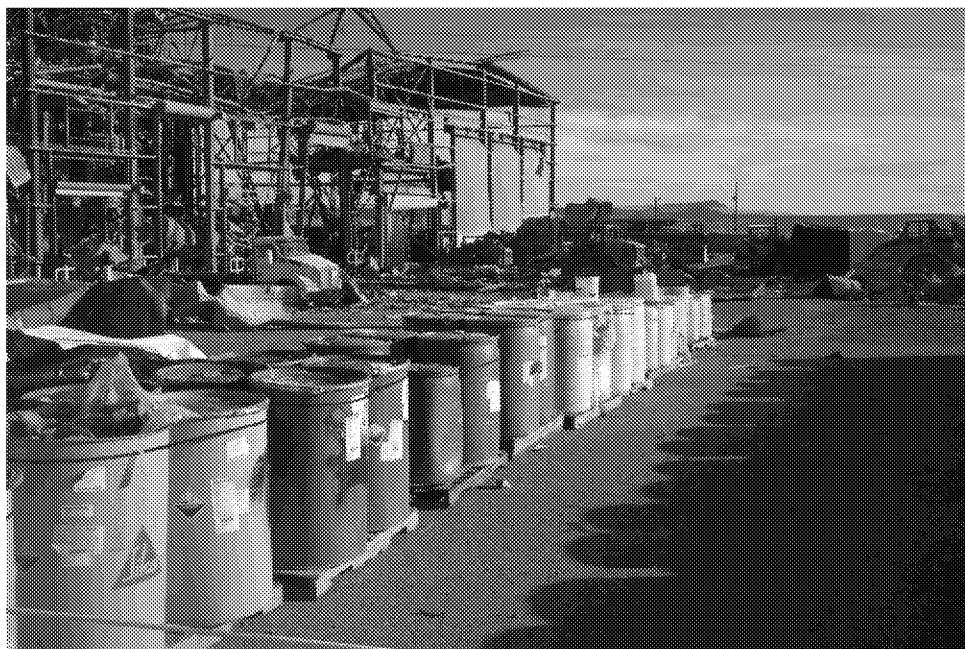
Photograph DCP-7670: Drums staged for stabilization at time of incident, containers of liquids and solids, looking East.

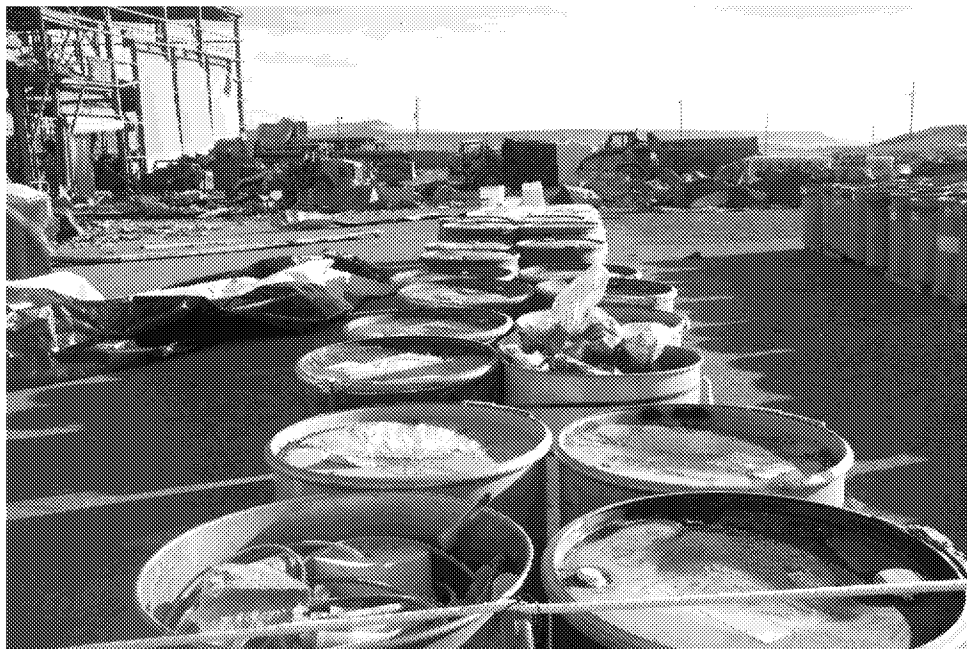
Photograph DCP-7671: Drums staged for stabilization at time of incident, containers of liquids and solids, looking East.

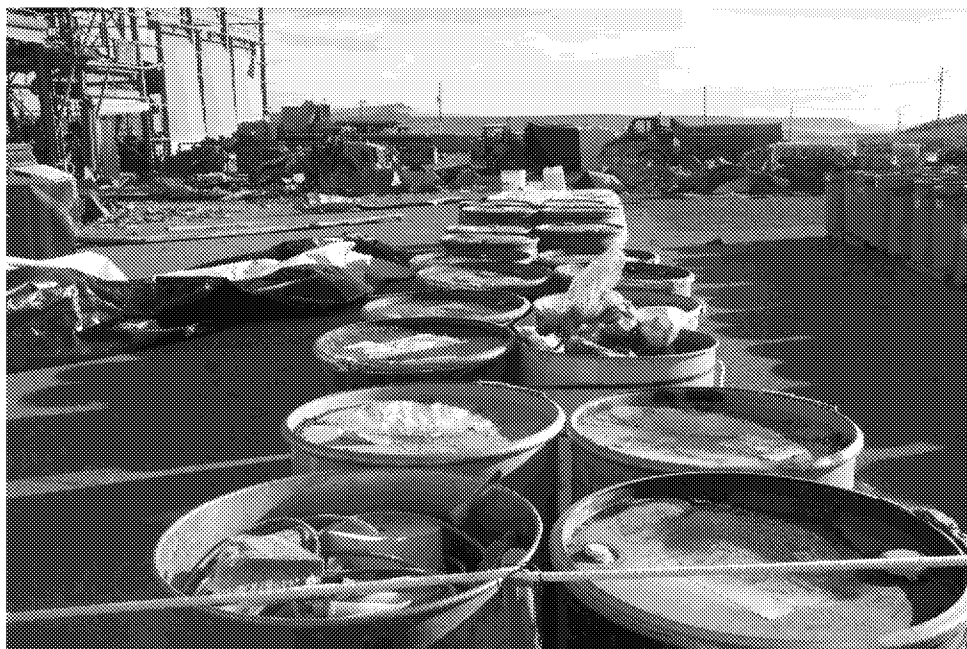
Photograph DCP-7672: : Drums staged for stabilization at time of incident, containers of liquids and solids, looking East.

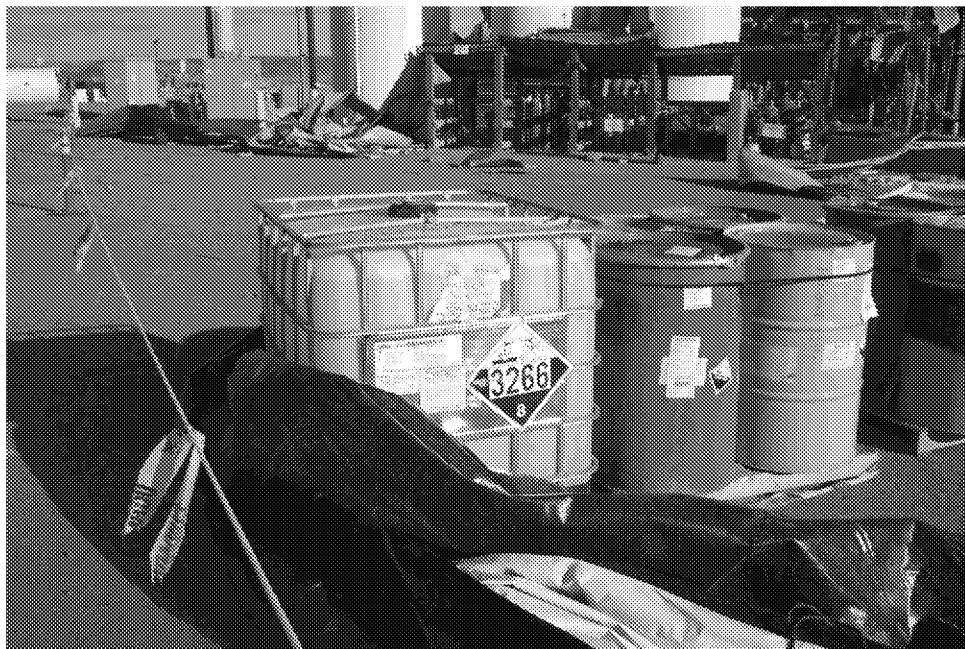
Photograph DCP-7673: Drums staged for stabilization at time of incident, containers of liquids and solids. Note compressed cylinder shed/racks in background, looking North.

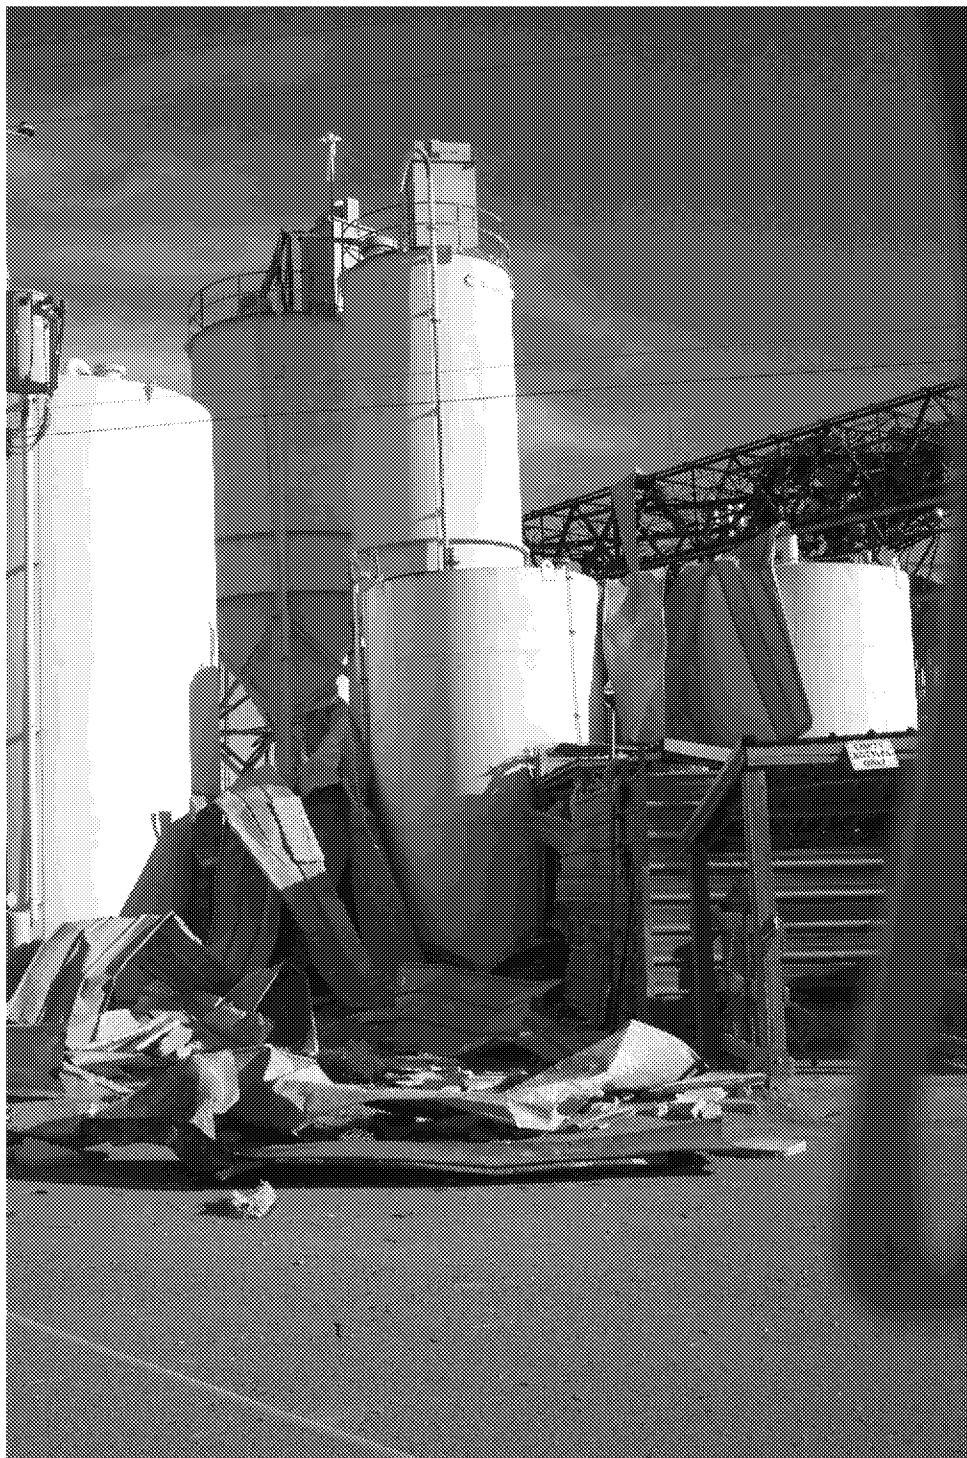
Photograph DCP-7674: Water and reagent tanks adjacent to containment building. Metal siding debris lays where it landed after incident. Note top to side seam on middle short tank has separated. Looking North.

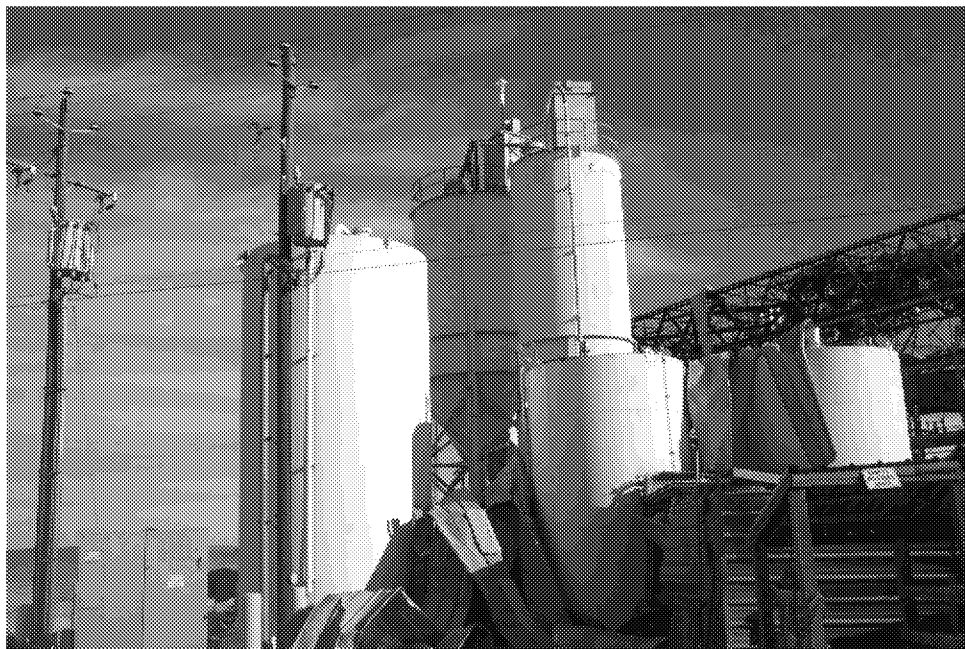
Photograph DCP-7675: Water and reagent tanks adjacent to containment building. Metal siding debris lays where it landed after incident. Note top to side seam on middle short tank has separated. Looking North.

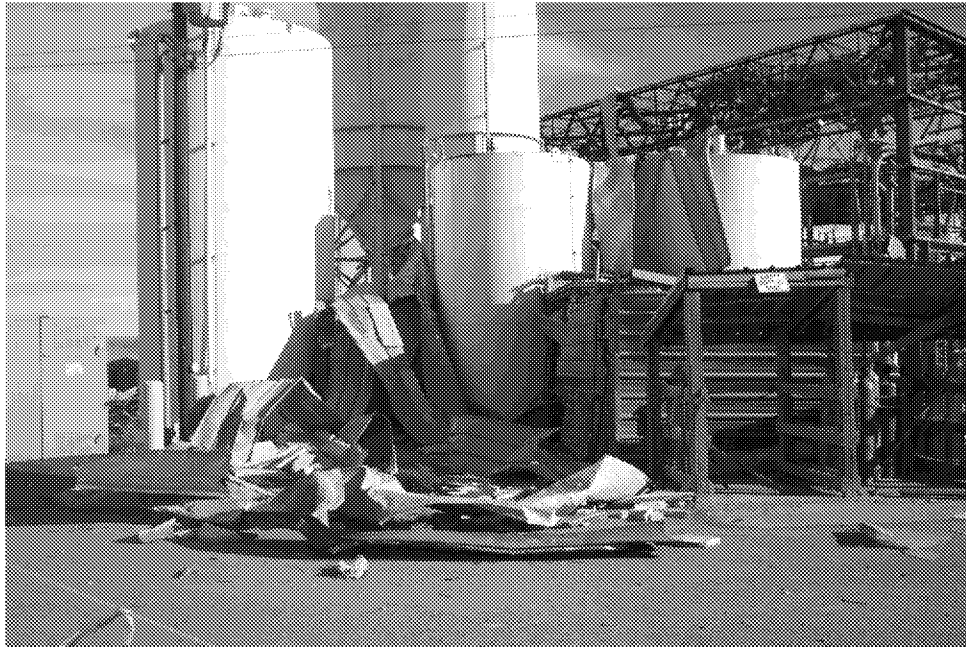
Photograph DCP-7676: Water and reagent tanks adjacent to containment building. Metal siding debris lies where it landed after incident. Note top to side seam on middle short tank has separated. High pressure cylinder storage in foreground, looking North.

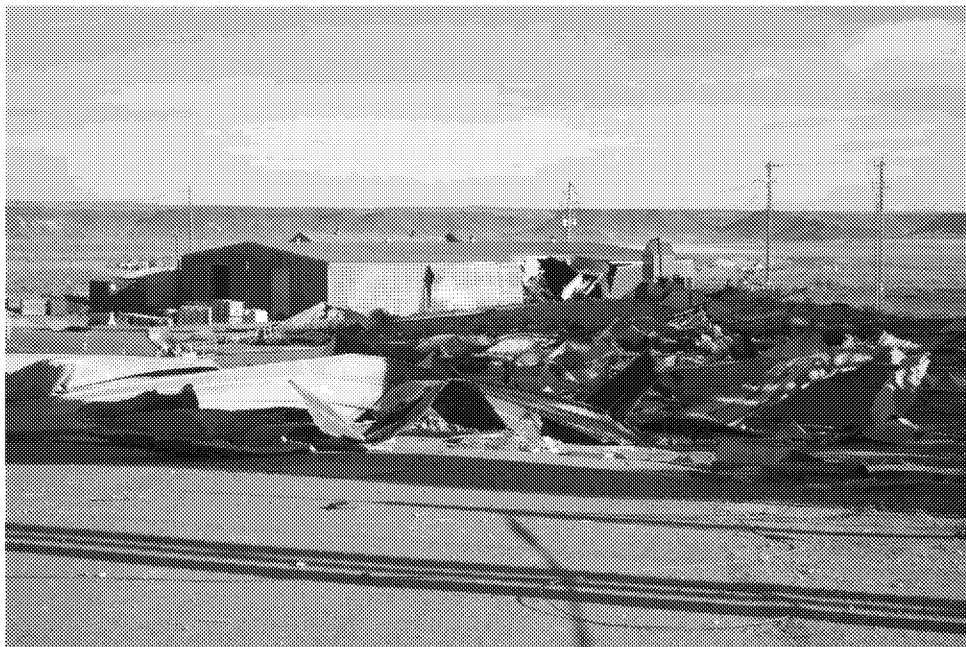
Photograph DCP7677: looking Northeast to Pad 7 building. Note demolished section of building and metal siding from containment building in foreground.

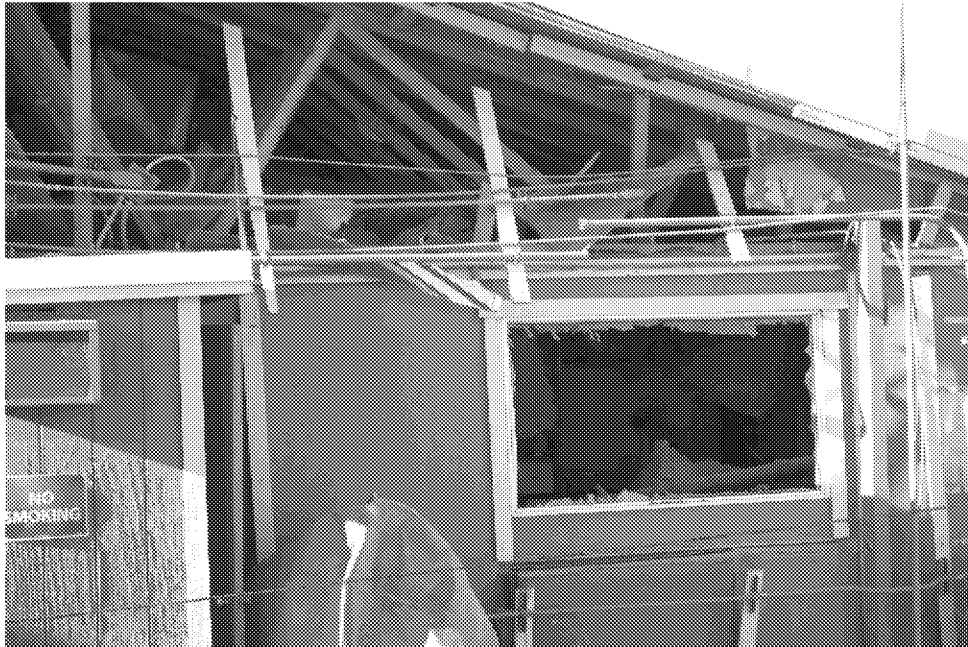
Photograph DCP-7678: Receiving laboratory, building siding caved in, windows broken, insulation hanging down inside, everything covered with gray dust inside, looking West.

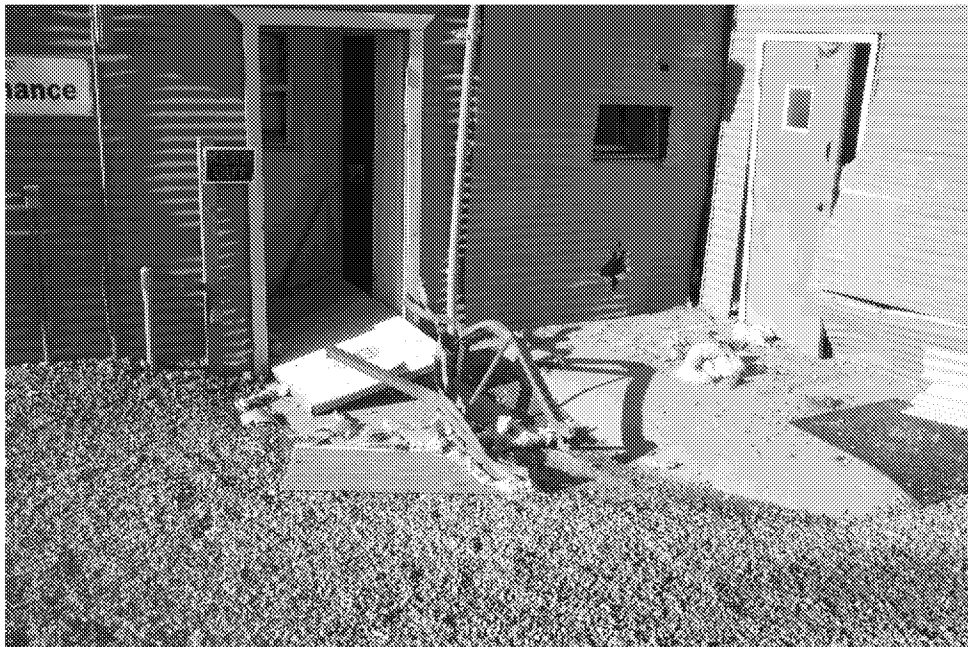
Photograph DCP7679: Old maintenance building, portion of containment building roof truss laying on ground, door laying on ground, door jamb on right askew and building siding bulging out, looking West.

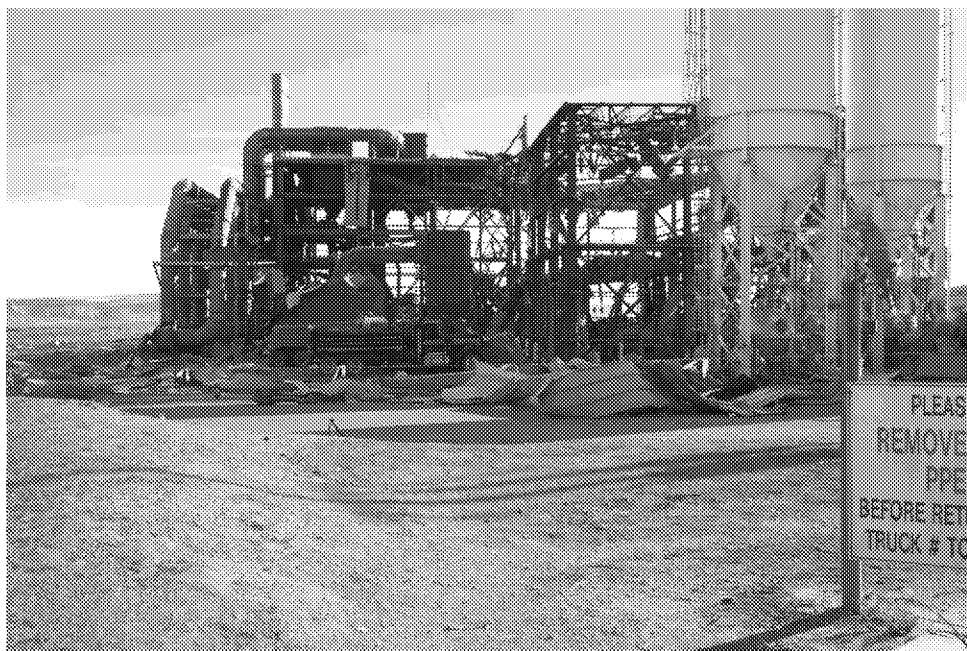
Photograph DCP-7680: Looking East at Northwest corner of Containment building.

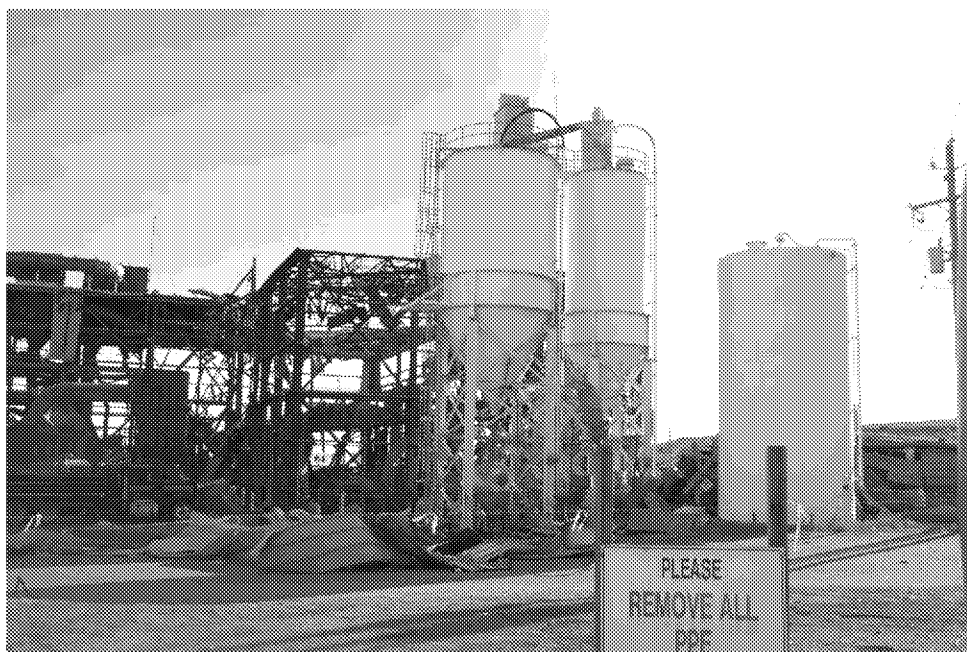
Photograph DCP-7681: Metal debris hanging on top and in supporting structure of reagent tanks, looking East.

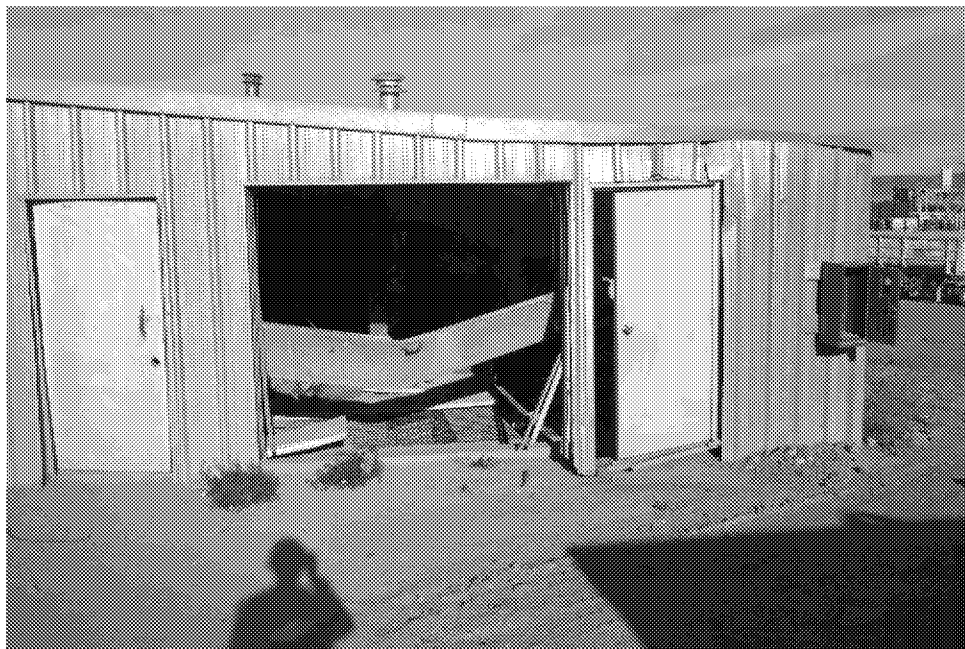
Photograph DCP-7682: Vehicle wash building, building distorted, sectional door separated and destroyed, looking North.

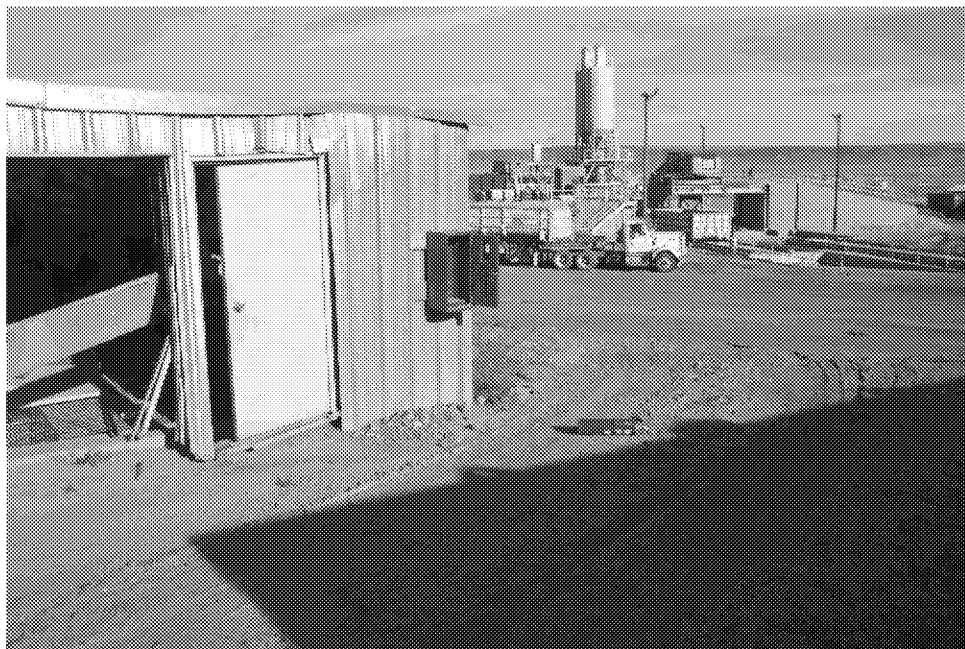
Photograph DCP-7683: Vehicle wash building, fire extinguisher laying on ground due to incident, looking Northeast.

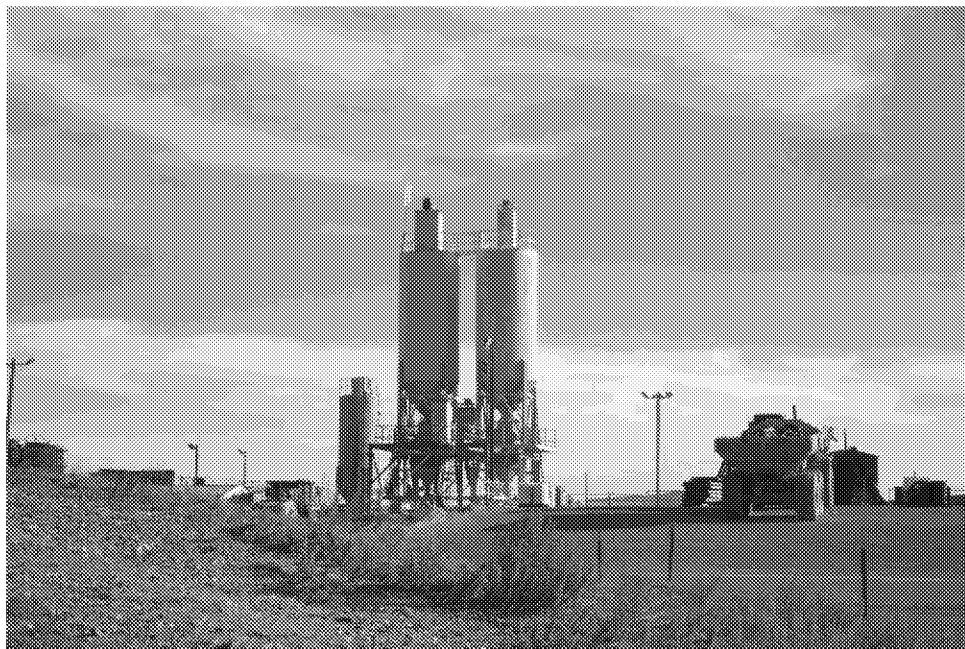
Photograph DCP-7684: Reagent silos at outdoor stabilization, walkway between two units does not appear to be level. Safety glass windows in haul truck were highly fractured window in operational building in front of haul truck was broken, looking East.

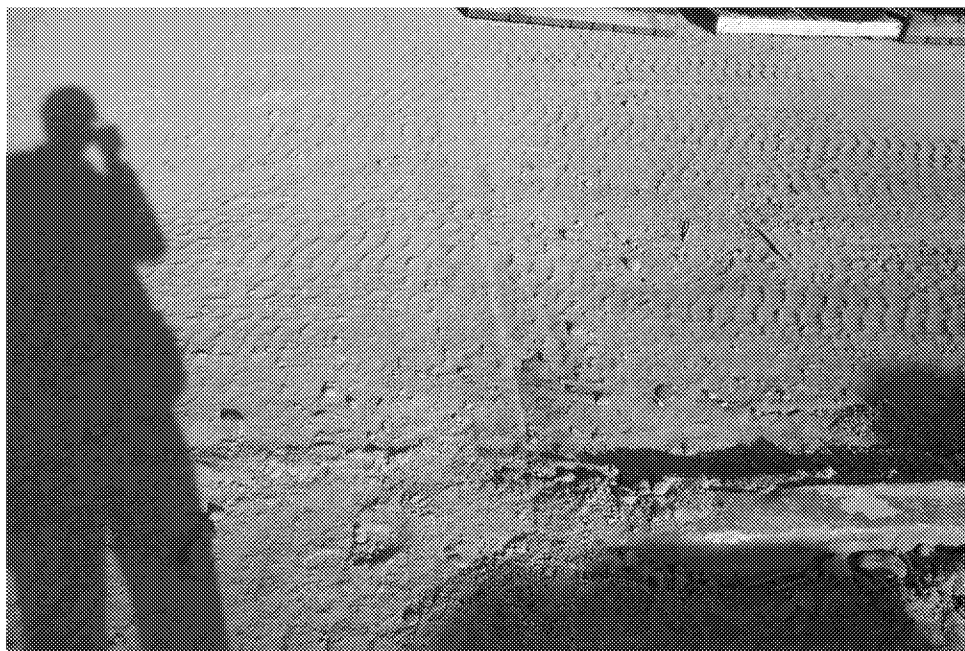
Photograph DCP-7685: Typical entrance into Pad 5 with dirt approach and dirt in containment, looking North.

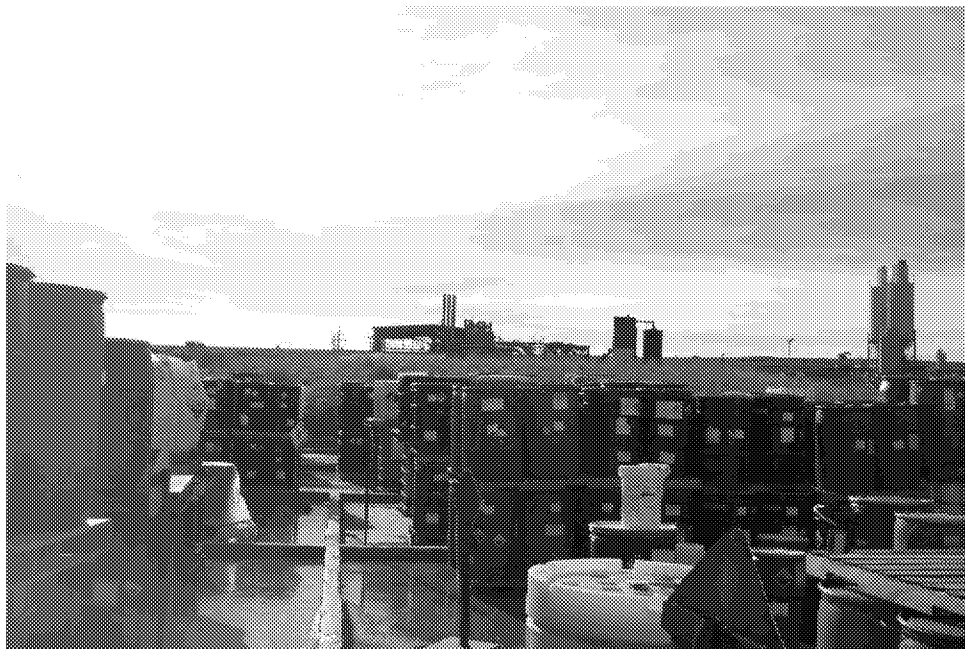
Photograph DCP-7686: Pad 5 looking South to Containment building. A piece of structural steel from the incident, estimated to weigh between 10 and 20 pounds, was embedded in the near hillside (closed Silo 3).

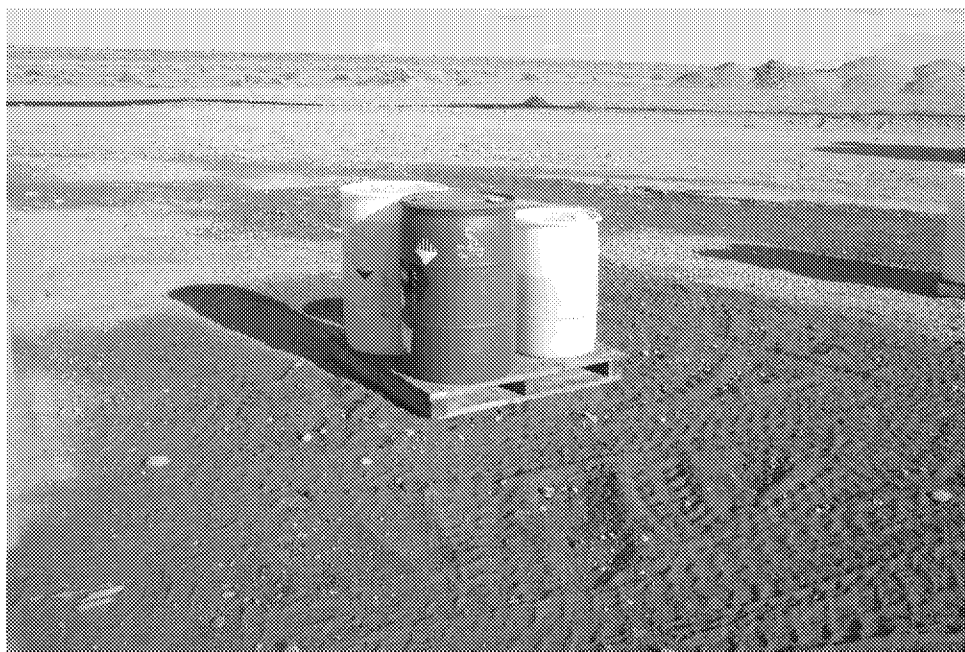
Photograph DCP-7687: Three drums of liquid waste out of containment at time of incident, looking North.

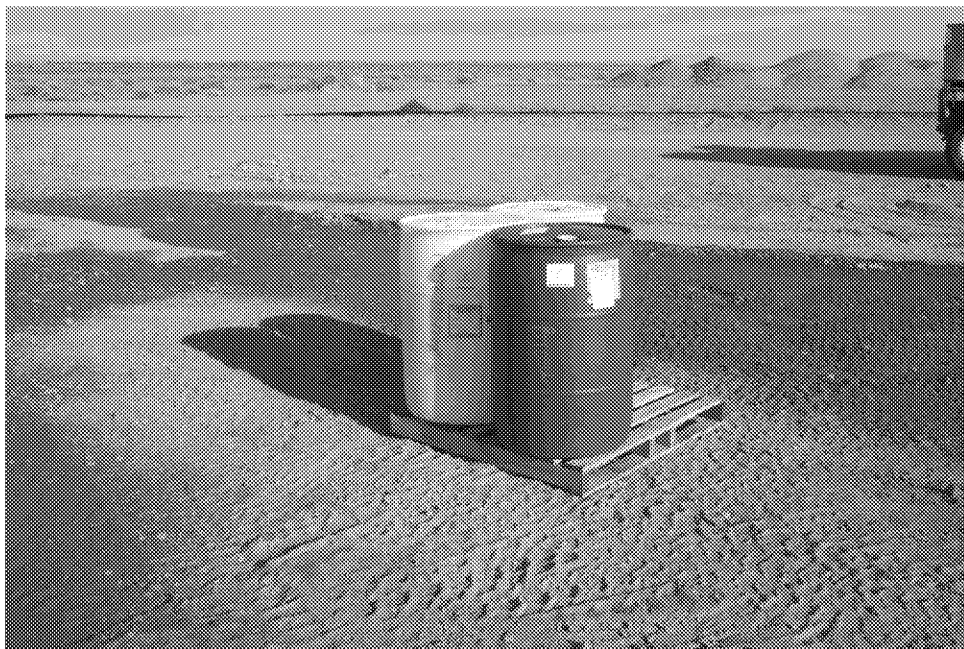
Photograph DCP-7688: Second pallet of three drums out of containment at time of incident, looking Northeast.

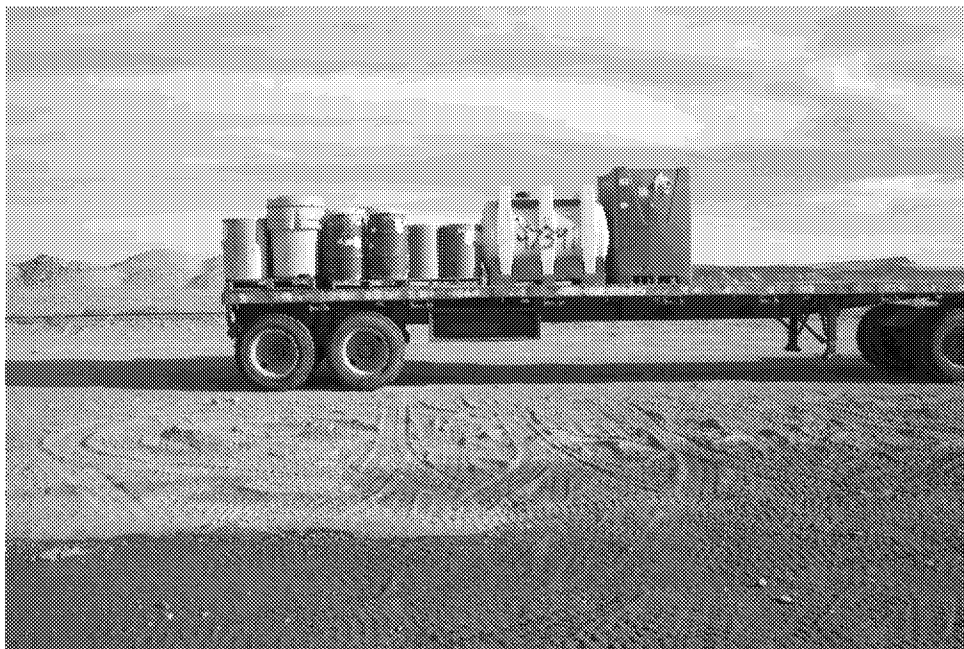
Photograph DCP-7689: Containers on one of three steel flat-bed trucks to transport waste on site, looking Northeast.

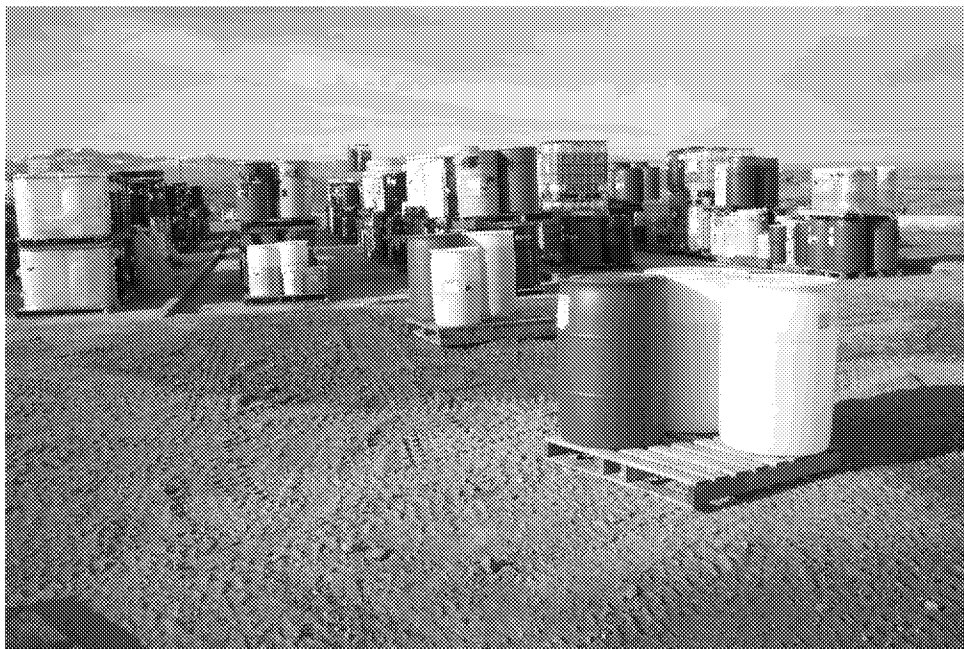
Photograph DCP-7690: Pallets of waste outside containment of Pad 5 from two previous pictures, looking West.

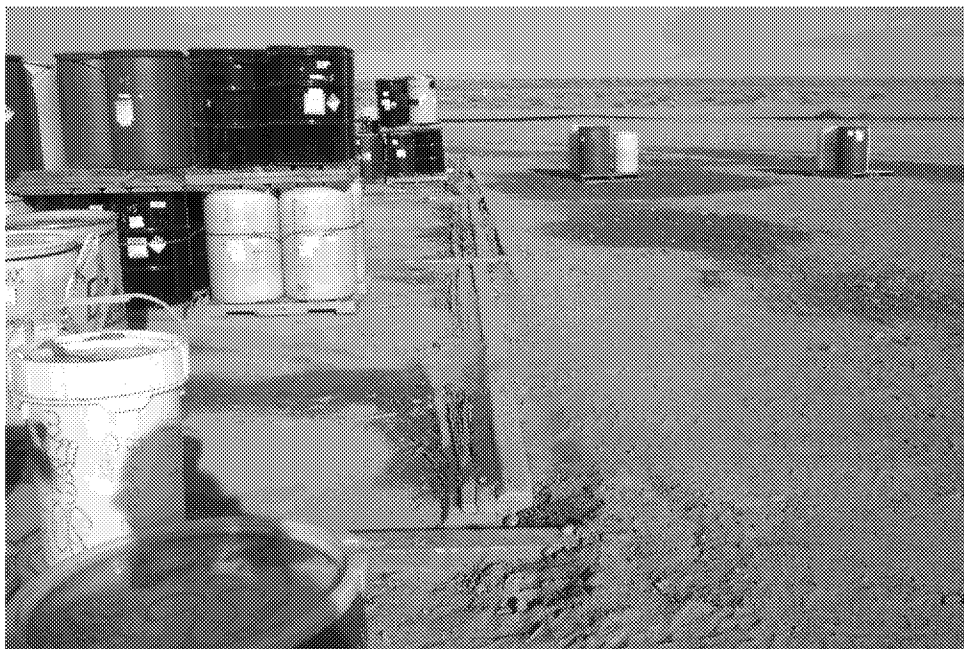
Photograph DCP-7691: Entrance into Pad 5 on East side, berm covered in dirt and improvised ramp into containment areas partially covered in dirt, looking North.

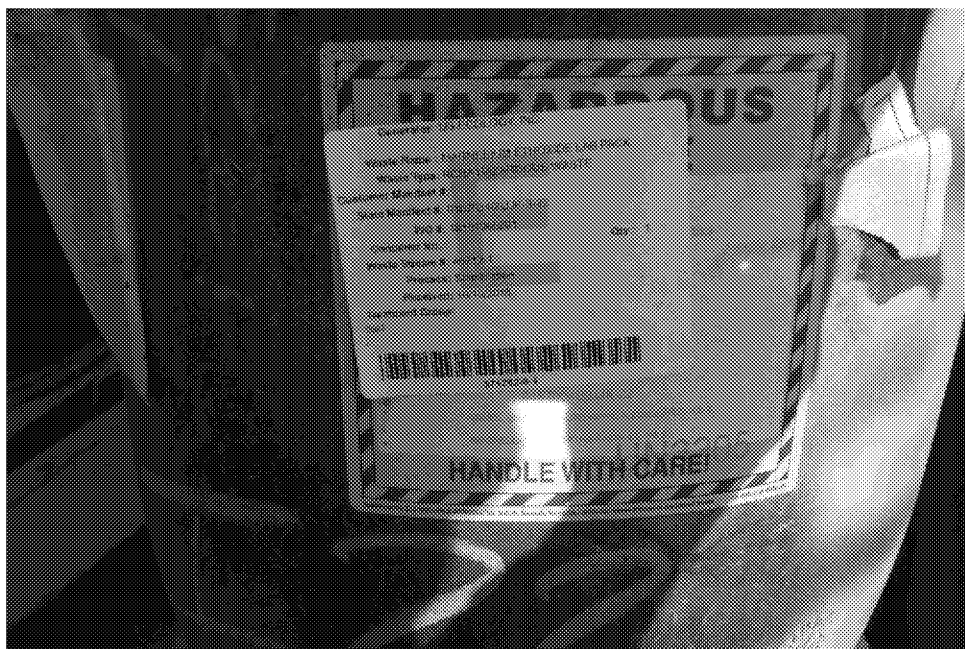
Photograph DCP-7692: One lab pack container of Magnesium Ethoxide located in Pad 5. This is the material that was involved in the incident.

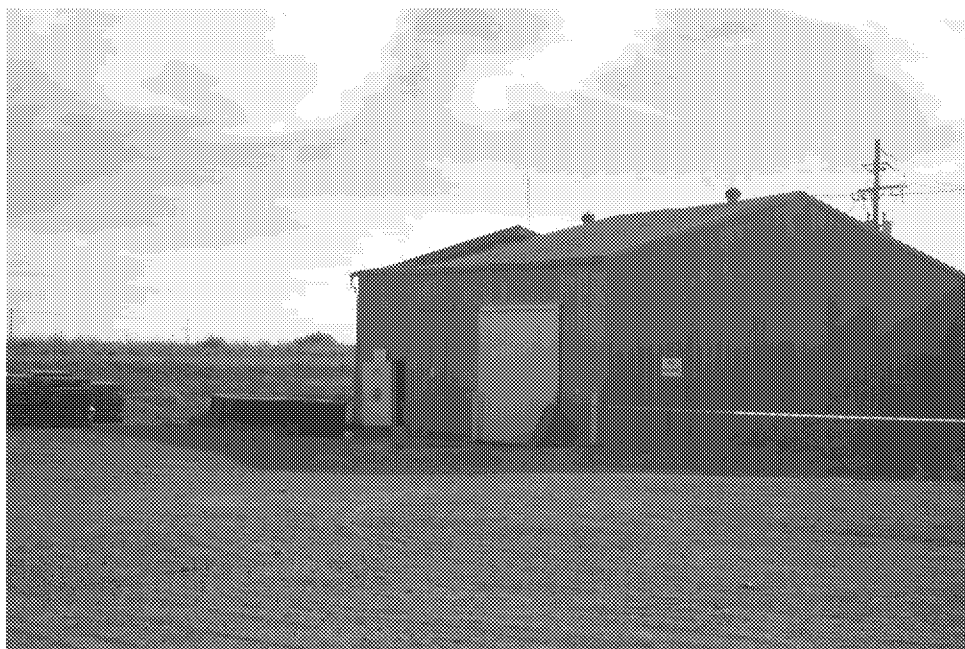
Photograph DCP-7693: PCB storage building, roofline dropped approximately one foot at east end of building. Door askew in jamb, looking East.

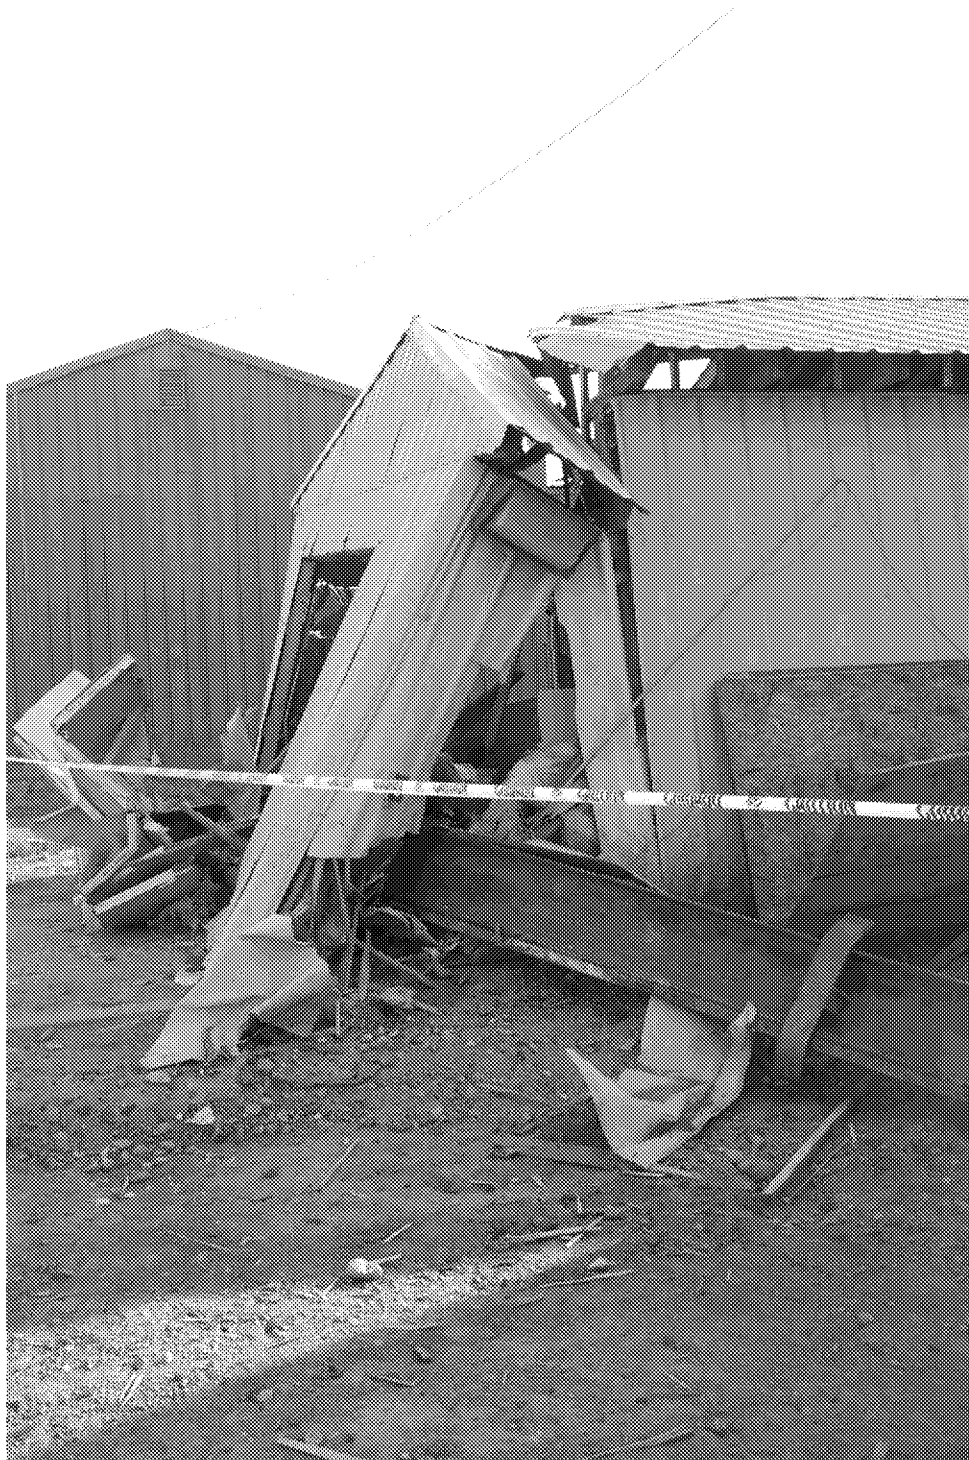
Photograph DCP-7695: Structural I-beam from Containment Building approximately 450 ft to the South completely sliced building located on North Side of Pad 7, looking East.
